**Flood Control Project Maintenance  
Levee Inspections**

**Fall 2011 Levee Maintenance Deficiency Summary Report**

**Reclamation District No. 1500 Sutter Basin**

**Levee Inspection Report By Mile - Fall 2011**

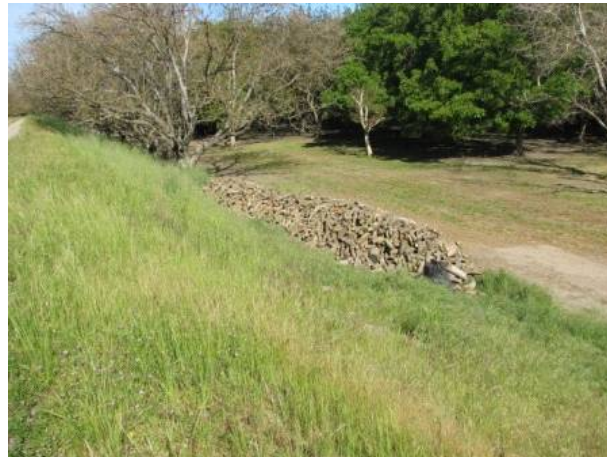
Levee Mile Report Line	1
Start Levee Mile	0.03
End Levee Mile	0.03
Location	Land Side
Category	Earthen Levee
Item	Encroachments
The firewood that was there last year has grown in size.	
johngw_f_20110923_395.jpg

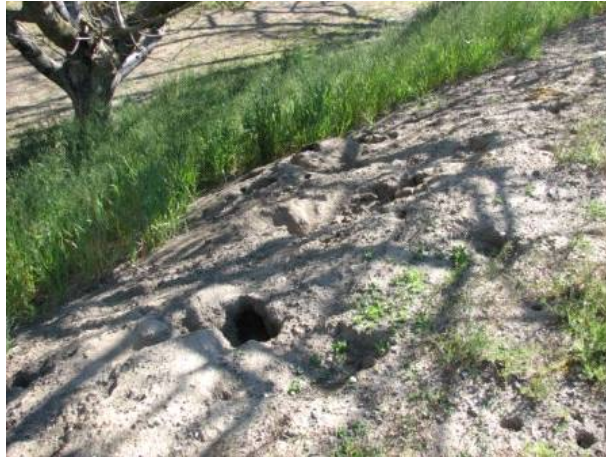
Levee Mile Report Line	5
Start Levee Mile	0.07
End Levee Mile	0.07
Location	Land Side
Category	Earthen Levee
Item	Animal Control
There are some old and a few new rodent holes that need to be backfill.	
johngw_f_20110923_386.jpg

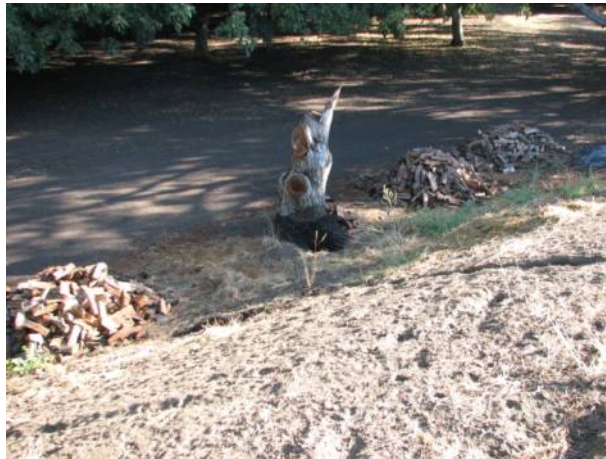
Levee Mile Report Line	6
Start Levee Mile	0.10
End Levee Mile	0.10
Location	Land Side
Category	Earthen Levee
Item	Encroachments
Firewood cut and piled at levee toe.	
johngw_f_20111007_843.jpg

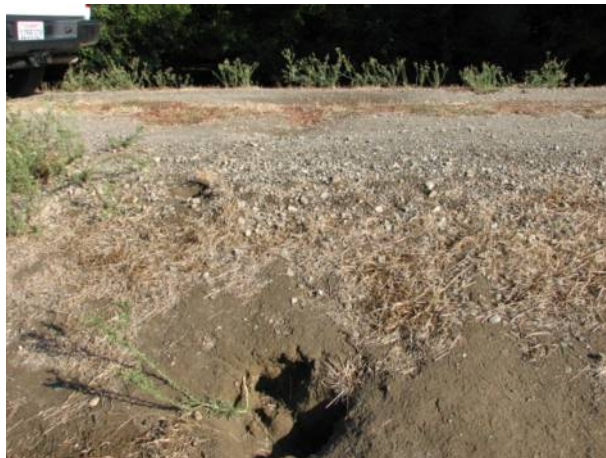
Levee Mile Report Line	7
Start Levee Mile	0.10
End Levee Mile	0.10
Location	Water Side
Category	Earthen Levee
Item	Animal Control
A view of a very large rodent hole on the waterside. Depression are on the crown.	
johngw_f_20111007_844.jpg

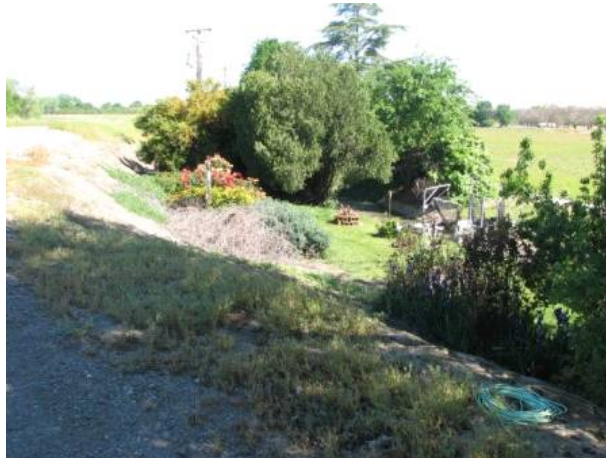
Levee Mile Report Line	19
Start Levee Mile	4.01
End Levee Mile	4.01
Location	Land Side
Category	Earthen Levee
Item	Encroachments
The landscape is planted into the encroachment zone within 15' of the toe.	
johngw_f_20110923_389.jpg

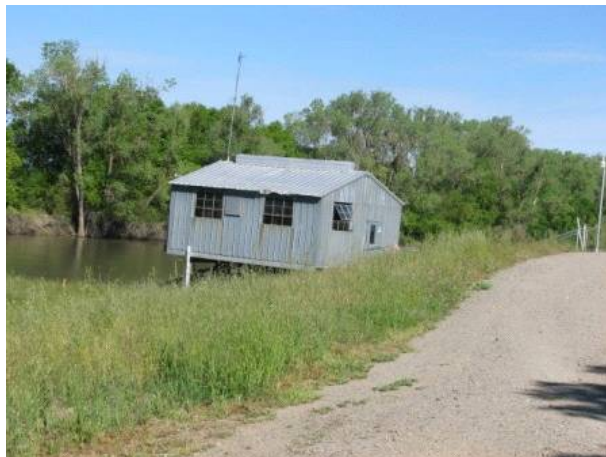
20	4.03	4.03	Earthen Levee	Encroachments	WS	PO	Buildings Inspector Comments: pump house concrete building	38.798048 ° -121.696148 °	38.798048 ° -121.696148 °	9 Y
21	4.04	4.16	Earthen Levee	Encroachments	LS	PO	Agricultural Ditch	38.798572 ° -121.696392 °	38.800080 ° -121.696653 °	54
22	4.20	4.20	Earthen Levee	Encroachments	LS	PO	Buildings	38.800550 ° -121.696752 °	38.800550 ° -121.696752 °	11 Y
23	4.65	4.65	Earthen Levee	Encroachments	LS	PO	Landscaping	38.803632 ° -121.702770 °	38.803632 ° -121.702770 °	12 Y
24	5.23	5.23	Earthen Levee	Encroachments	WS	PO	Buildings Inspector Comments: pump house	38.802342 ° -121.712995 °	38.802342 ° -121.712995 °	13
25	5.38	5.38	Earthen Levee	Encroachments	LS	CO	Landscaping	38.803240 ° -121.715402 °	38.803240 ° -121.715402 °	14 Y
26	5.67	5.75	Earthen Levee	Encroachments	WS	PO	Buildings Inspector Comments: Sting Rayz Beach Boardwalk Marina waterside berm	38.803005 ° -121.720380 °	38.803238 ° -121.721847 °	52 Y

Levee Mile Report Line	20
Start Levee Mile	4.03
End Levee Mile	4.03
Location	Water Side
Category	Earthen Levee
Item	Encroachments
The building is the new pumping plant for Sutter Mutual Water. This replaces the abanded one.	
johngw_f_20110923_390.jpg

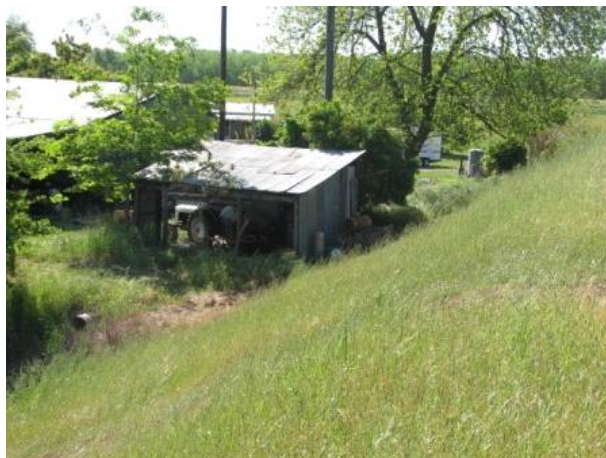
Levee Mile Report Line	22
Start Levee Mile	4.20
End Levee Mile	4.20
Location	Land Side
Category	Earthen Levee
Item	Encroachments
The equipment shed encroaches into the toe of the levee.	
johngw_f_20110923_391.jpg

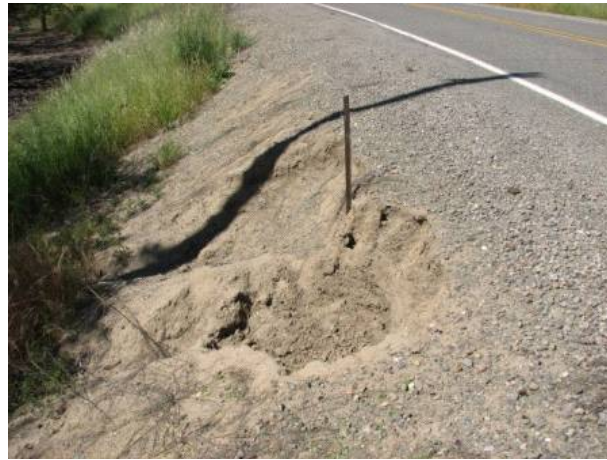
There has been some erosion along the roadside, need to repair the shoulder.

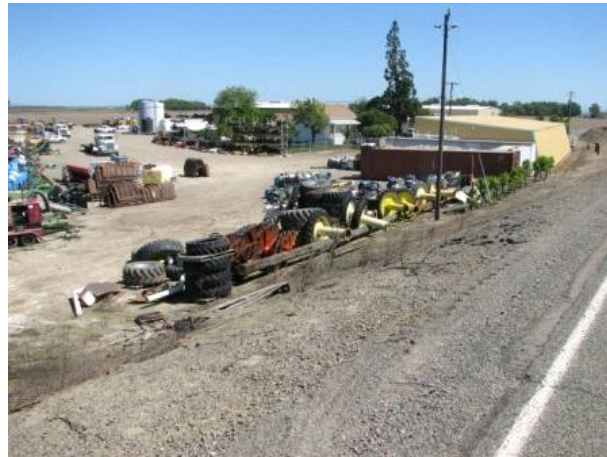
Levee Mile Report Line	46
Start Levee Mile	13.18
End Levee Mile	13.18
Location	Land Side
Category	Earthen Levee
Item	Encroachments
Next to the building there are tires and axles stored at the toe.	
johngw_f_20110923_444.jpg

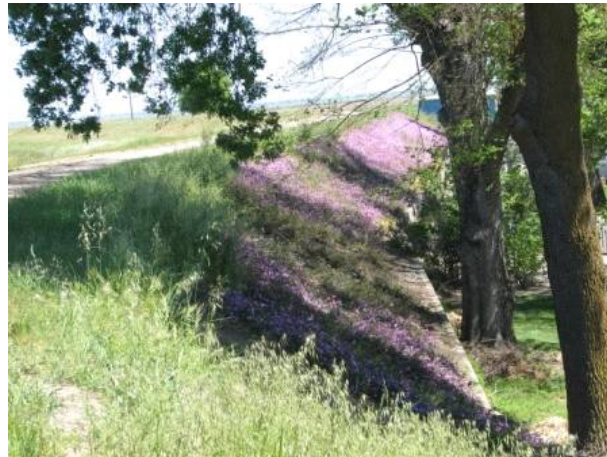
Levee Mile Report Line	62
Start Levee Mile	19.22
End Levee Mile	19.22
Location	Land Side
Category	Earthen Levee
Item	Encroachments
The groundcover is on the levee slope above the concrete retaining wall. The groundcover is irrigated.	
johngw_f_20110923_417.jpg

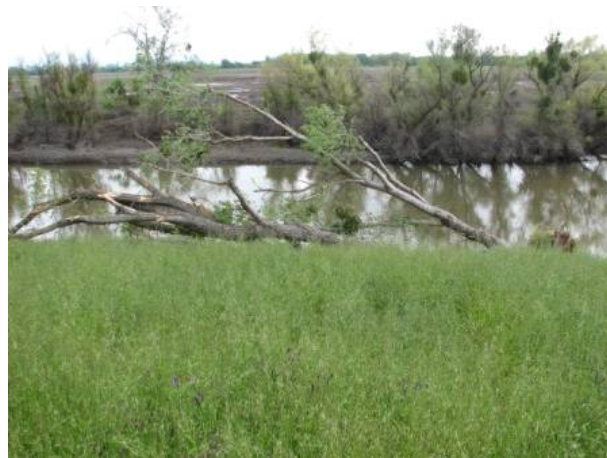
Levee Mile Report Line	4
Start Levee Mile	9.92
End Levee Mile	9.92
Location	Water Side
Category	Earthen Levee
Item	Trim / Thin Trees
A tree has been blown over and the roots have been up rooted. Need to repair the damage area.	
johngw_f_20110923_578.jpg

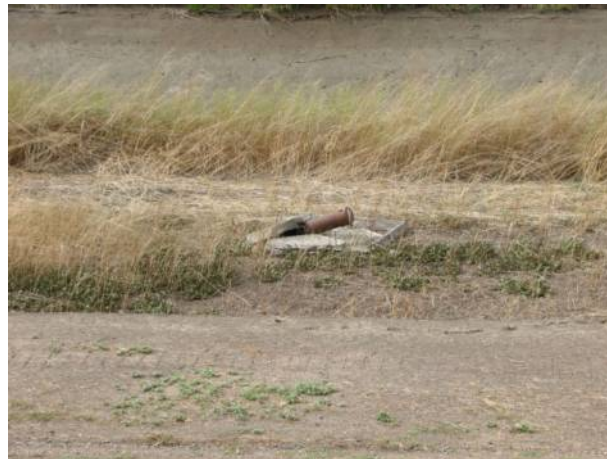
Levee Mile Report Line	6
Start Levee Mile	14.50
End Levee Mile	14.50
Location	Land Side
Category	Concrete Floodwalls
Item	Underseepage Relief Wells

6	14.50	14.50	Concrete Floodwalls	Underseepage Relief Wells	LS	M	Inspector Comments: Relief well casing broken up and knocked over by a piece of equipment.	38.950673 ° -121.673060 °	38.950673 ° -121.673060 °	4 Y
7	15.74	15.74	Earthen Levee	Trim / Thin Trees	WS	C	Thin trees to allow visibility of the ground and room to flood fight. Inspector Comments: A cottonwood tree has fallen. Need to cut the tree up. Repair damage caused by the root ball at the toe.	38.963546 ° -121.689317 °	38.963546 ° -121.689317 °	9
8	16.08	16.08	Earthen Levee	Crown Surface / Depressions / Rutting	CR	W	Keep the crown roadway free of vegetation. Inspector Comments: The crown has low growing vegetation spotted throughout the unit. The crown needs to be sprayed in the fall to control the vegetation.	38.966637 ° -121.694278 °	38.966637 ° -121.694278 °	13 Y
9	18.46	18.46	Earthen Levee	Trim / Thin Trees	WS	C	Thin trees to allow visibility of the ground and room to flood fight. Inspector Comments: A cottonwood tree has fallen. Need to cut the tree up. Repair the damage caused by the root ball.	38.989641 ° -121.727622 °	38.989641 ° -121.727622 °	10

The relief well casing needs to be repaired.
